OIL ANALYSIS REPORT

KAMAG T6 (S/N 871)

Hydraulic System

HVLP 32 (222 GAL)

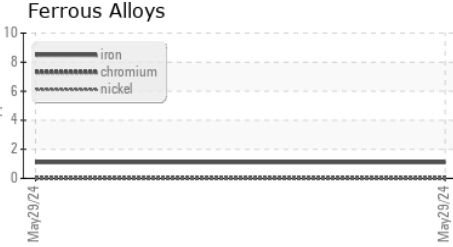
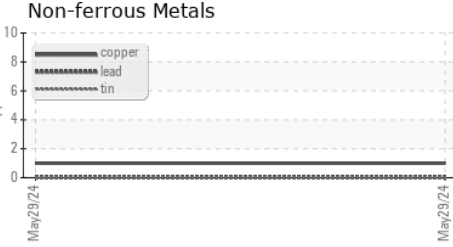
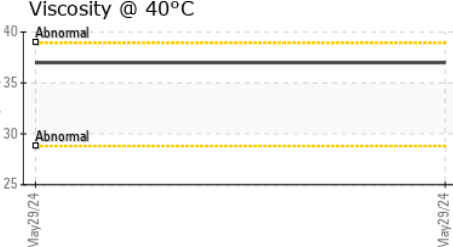
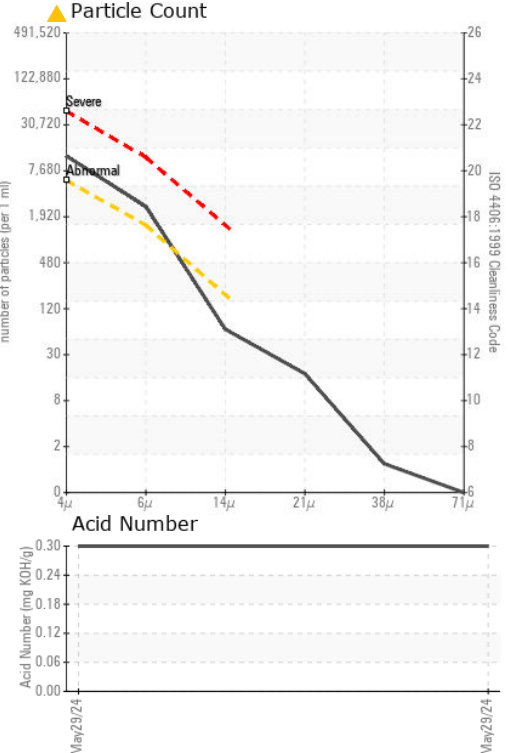
GRAPHS

There is a high amount of silt (particulates < 14 microns in size) present in the oil.

| FLUID CLEANLINESS | | method | limit/base | current | history1 | history2 |
|---|--|---|---|---|---|---|
| Particles >4µm | | ASTM D7647 | >5000 | ▲ 10422 | --- | --- |
| Particles >6µm | | ASTM D7647 | >1300 | ● 2285 | --- | --- |
| Oil Cleanliness | | ISO 4406 (c) | >19/17/14 | ▲ 21/18/13 | --- | --- |

No corrective action is recommended at this time. Resample at the next service interval to monitor.
