Area
SMART OIL 6000

Machine Id
HERTZ VD028936 - INDEPENDENT PRINTING

Component
Compressor

OIL ANALYSIS REPORT

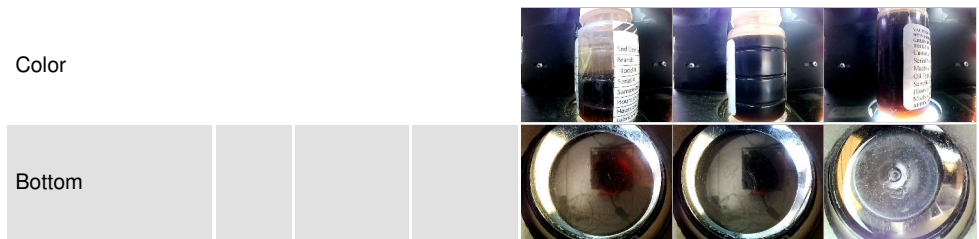
SAMPLE IMAGES	method	limit/base	current	history1	history2
---------------	--------	------------	---------	----------	----------

VISUAL	method	limit/base	current	history1	history2
White Metal	scalar	*Visual	NONE	NONE	NONE
Yellow Metal	scalar	*Visual	NONE	NONE	NONE
Precipitate	scalar	*Visual	NONE	NONE	NONE
Silt	scalar	*Visual	NONE	NONE	NONE
Debris	scalar	*Visual	NONE	NONE	NONE
Sand/Dirt	scalar	*Visual	NONE	NONE	NONE
Appearance	scalar	*Visual	NORML	NORML	NORML
Odor	scalar	*Visual	NORML	NORML	NORML
Emulsified Water	scalar	*Visual	>0.1	NEG	NEG
Free Water	scalar	*Visual		NEG	NEG

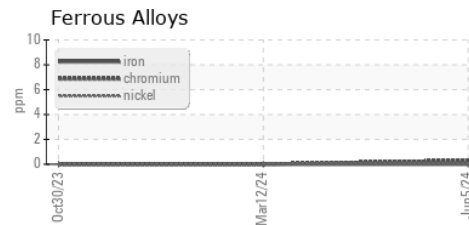
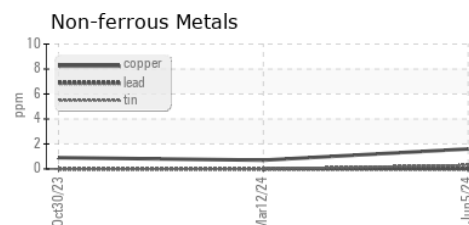
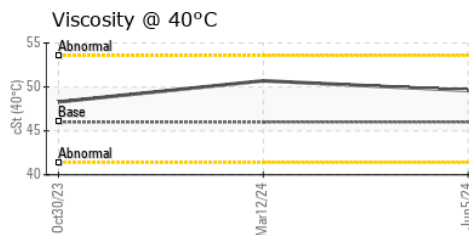
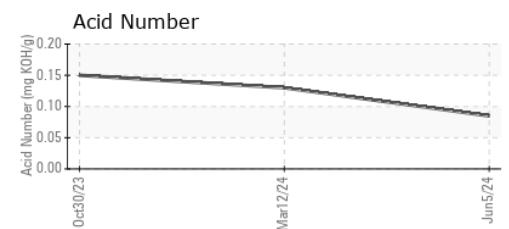
GRAPHS

All component wear rates are normal.

The AN level is acceptable for this fluid. The condition of the oil is suitable for further service.

Resample at the next service interval to monitor.
