OIL ANALYSIS REPORT

Area
[BOSTON]
 Machine Id
ALSTOM R161
 Component
Gearbox
 Fluid
TOTAL CARTER SH 220 (3 GAL)

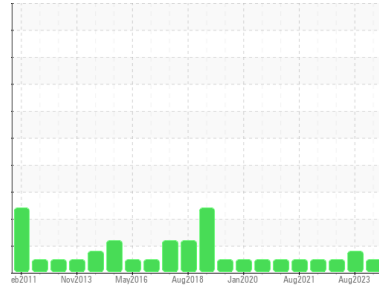
Sample Rating Trend

NORMAL

Resample at the next service interval to monitor.

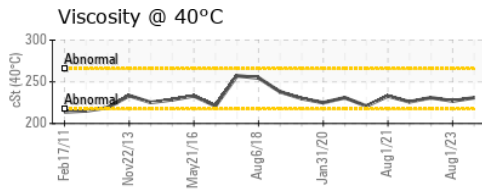
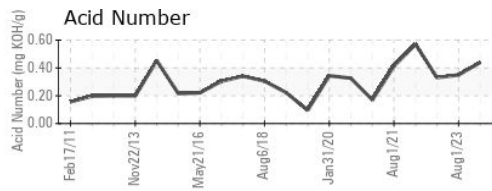
GRAPHS

method	limit/base	current	history1	history2
Iron	ppm	ASTM D5185m >200	189	▲ 234	186
Chromium	ppm	ASTM D5185m >10	1	1	1
Nickel	ppm	ASTM D5185m >10	0	0	<1
Titanium	ppm	ASTM D5185m	<1	0	<1
Silver	ppm	ASTM D5185m	0	0	0
Aluminum	ppm	ASTM D5185m >25	3	4	3
Lead	ppm	ASTM D5185m >50	<1	4	3
Copper	ppm	ASTM D5185m >200	41	37	36
Tin	ppm	ASTM D5185m >10	0	<1	<1
Antimony	ppm	ASTM D5185m >5	---	---	---
Vanadium	ppm	ASTM D5185m	0	0	0
Cadmium	ppm	ASTM D5185m	0	0	0
