OIL ANALYSIS REPORT

Machine Id
H26 PRESS 2

Component
Gearbox

Fluid
MOBIL MOBILGEAR 600 XP 220 (--- GAL)

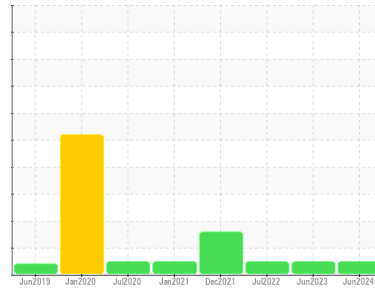
Sample Rating Trend

NORMAL

All component wear rates are normal.

There is no indication of any contamination in the oil.

The AN level is acceptable for this fluid. The condition of the oil is suitable for further service.

Resample at the next service interval to monitor.

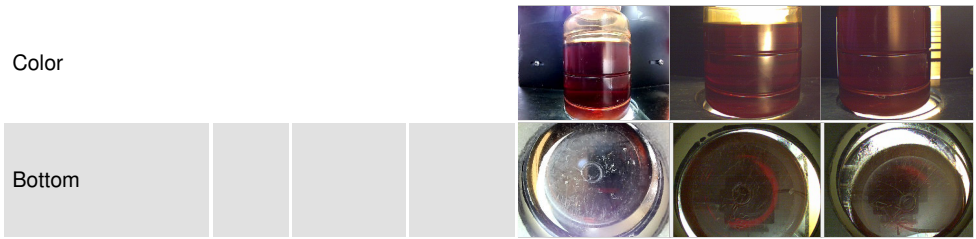
SAMPLE IMAGES	method	limit/base	current	history1	history2
---------------	--------	------------	---------	----------	----------

VISUAL	method	limit/base	current	history1	history2
White Metal	scalar	*Visual	NONE	NONE	NONE
Yellow Metal	scalar	*Visual	NONE	NONE	NONE
Precipitate	scalar	*Visual	NONE	NONE	NONE
Silt	scalar	*Visual	NONE	NONE	NONE
Debris	scalar	*Visual	NONE	NONE	NONE
Sand/Dirt	scalar	*Visual	NONE	NONE	NONE
Appearance	scalar	*Visual	NORML	NORML	NORML
Odor	scalar	*Visual	NORML	NORML	NORML
Emulsified Water	scalar	*Visual	>0.2	NEG	NEG
Free Water	scalar	*Visual		NEG	NEG

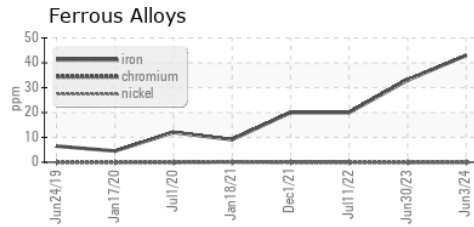
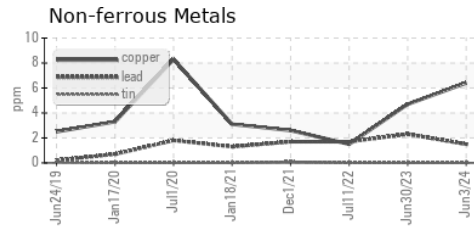
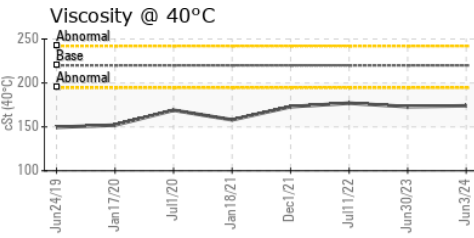
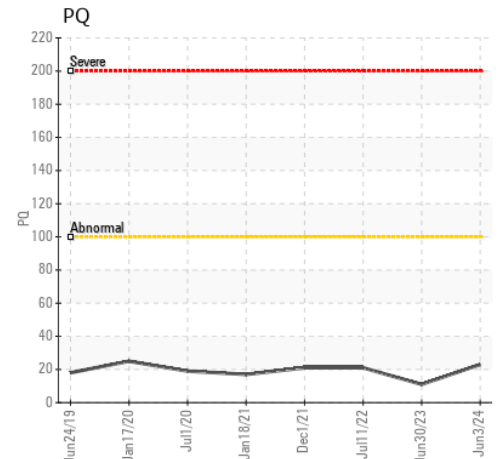
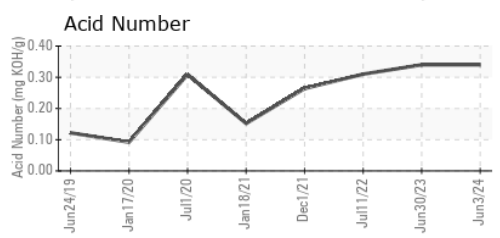
GRAPHS

method	limit/base	current	history1	history2
PQ	ASTM D8184		23	11	21
Iron	ppm	ASTM D5185m >200	43	33	20
Chromium	ppm	ASTM D5185m >15	0	0	0
Nickel	ppm	ASTM D5185m >15	0	0	0
Titanium	ppm	ASTM D5185m	0	0	0
Silver	ppm	ASTM D5185m	0	0	<1
Aluminum	ppm	ASTM D5185m >25	<1	0	<1
Lead	ppm	ASTM D5185m >100	2	2	2
Copper	ppm	ASTM D5185m >200	6	5	2
Tin	ppm	ASTM D5185m >25	0	0	0
Antimony	ppm	ASTM D5185m >5	---	---	---
Vanadium	ppm	ASTM D5185m	<1	0	0
Cadmium	ppm	ASTM D5185m	0	0	0

method	limit/base	current	history1	history2
Acid Number (AN)	mg KOH/g	ASTM D8045	0.34	0.34	0.31
