Machine ID
SULLIVAN PALATEK 19FE00229 - ROSBORO LUMBER (S/N 19FE000229)

Compressor

OIL ANALYSIS REPORT

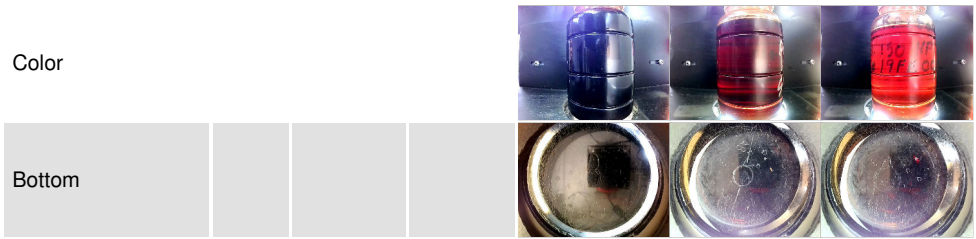
SAMPLE IMAGES	method	limit/base	current	history1	history2
---------------	--------	------------	---------	----------	----------

VISUAL	method	limit/base	current	history1	history2	
White Metal	scalar	*Visual	NONE	NONE	LIGHT	NONE
Yellow Metal	scalar	*Visual	NONE	NONE	NONE	NONE
Precipitate	scalar	*Visual	NONE	NONE	NONE	NONE
Silt	scalar	*Visual	NONE	NONE	NONE	NONE
Debris	scalar	*Visual	NONE	LIGHT	NONE	NONE
Sand/Dirt	scalar	*Visual	NONE	NONE	NONE	NONE
Appearance	scalar	*Visual	NORML	NORML	NORML	NORML
Odor	scalar	*Visual	NORML	NORML	NORML	NORML
Emulsified Water	scalar	*Visual	>0.1	NEG	NEG	NEG
Free Water	scalar	*Visual		NEG	NEG	NEG
