HERTZ VD018480 - CAMPERS INN RV

Compressor

OIL ANALYSIS REPORT

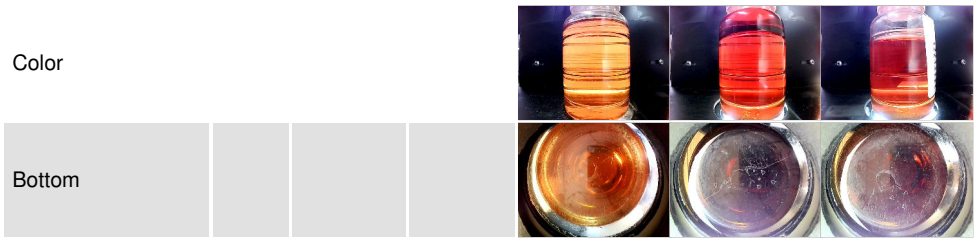
SAMPLE IMAGES	method	limit/base	current	history1	history2
---------------	--------	------------	---------	----------	----------

VISUAL	method	limit/base	current	history1	history2
White Metal	scalar	*Visual	NONE	NONE	NONE
Yellow Metal	scalar	*Visual	NONE	NONE	NONE
Precipitate	scalar	*Visual	NONE	NONE	NONE
Silt	scalar	*Visual	NONE	NONE	NONE
Debris	scalar	*Visual	NONE	NONE	NONE
Sand/Dirt	scalar	*Visual	NONE	NONE	NONE
Appearance	scalar	*Visual	NORML	NORML	NORML
Odor	scalar	*Visual	NORML	NORML	NORML
Emulsified Water	scalar	*Visual	>0.1	NEG	NEG
Free Water	scalar	*Visual		NEG	NEG

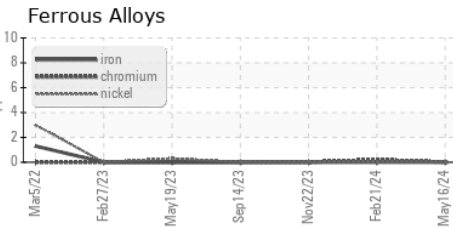
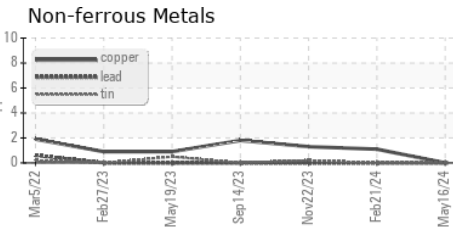
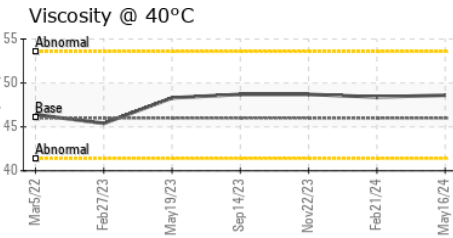
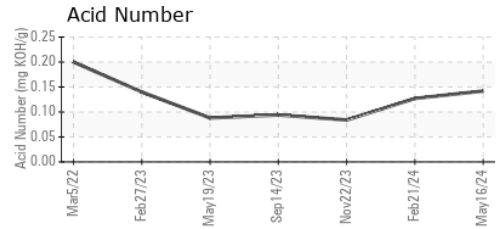
GRAPHS

All component wear rates are normal.

The AN level is acceptable for this fluid. The condition of the oil is suitable for further service.

Resample at the next service interval to monitor.
