OIL ANALYSIS REPORT

Area
FOUR MILE RIDGE [200009521]
 Machine Id
83442 SITE 9
 Component
Wind Turbine Gearbox
 Fluid
CASTROL OPTIGEAR SYNTHETIC X 320 (--- LTR)

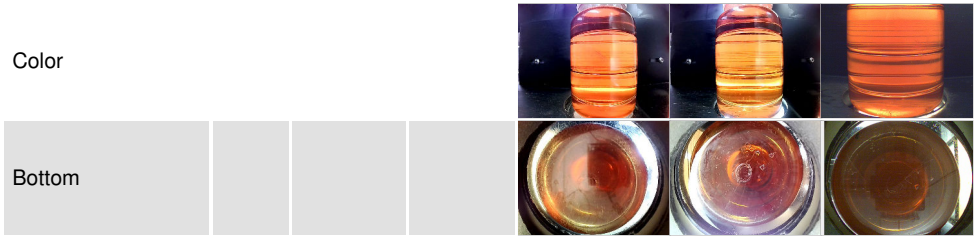
SAMPLE IMAGES	method	limit/base	current	history1	history2
---------------	--------	------------	---------	----------	----------

VISUAL	method	limit/base	current	history1	history2
White Metal	scalar	*Visual	NONE	NONE	NONE
Yellow Metal	scalar	*Visual	NONE	NONE	NONE
Precipitate	scalar	*Visual	NONE	NONE	NONE
Silt	scalar	*Visual	NONE	NONE	NONE
Debris	scalar	*Visual	NONE	NONE	NONE
Sand/Dirt	scalar	*Visual	NONE	NONE	NONE
Appearance	scalar	*Visual	NORML	NORML	NORML
Odor	scalar	*Visual	NORML	NORML	NORML
Emulsified Water	scalar	*Visual	>0.05	NEG	NEG
Free Water	scalar	*Visual		NEG	NEG

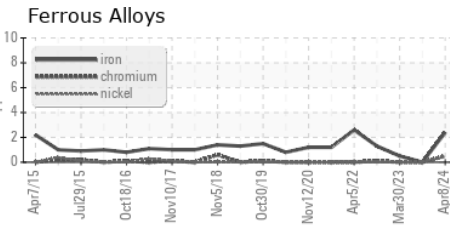
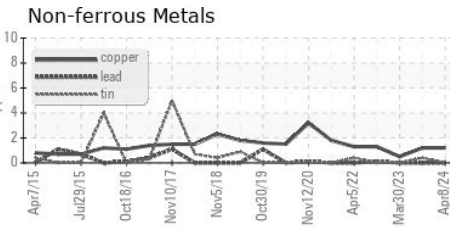
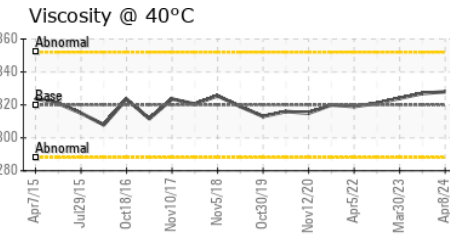
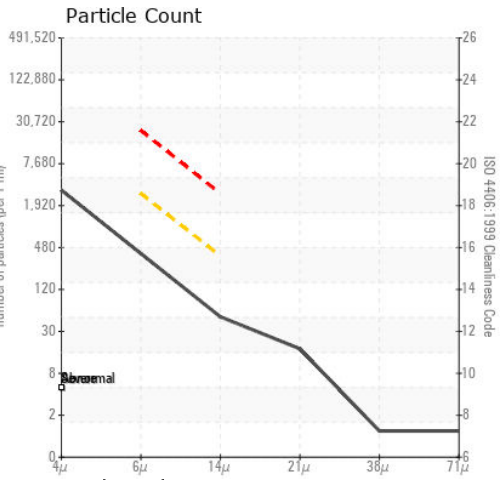
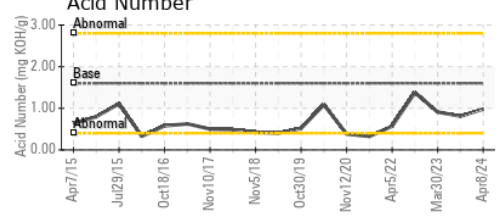
GRAPHS

All component wear rates are normal.

There is no indication of any contamination in the component. The amount and size of particulates present in the system is acceptable.

The AN level is acceptable for this fluid. The condition of the oil is suitable for further service.

Resample at the next service interval to monitor.
