OIL ANALYSIS REPORT

Area
Bridgewater
 Machine ID
CATERPILLAR 5206
 Component
Hydraulic System
 Fluid
 {not provided} (--- GAL)

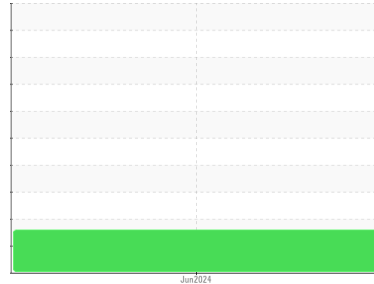
Sample Rating Trend

Chromium and iron ppm levels are noted. All other component wear rates are normal.

There is no indication of any contamination in the oil.

The condition of the oil is acceptable for the time in service.

Resample at the next service interval to monitor. Please specify the brand, type, and viscosity of the oil on your next sample.
