OIL ANALYSIS REPORT

CMPL UNCOILER - MAIN (S/N 16-5300-0115)

Gearbox

GEAR OIL ISO 220 (--- QTS)

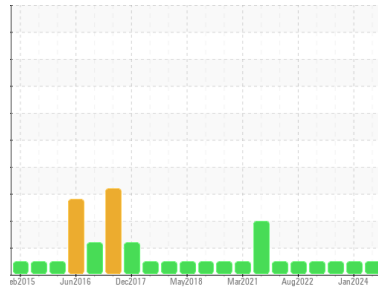
Sample Rating Trend

NORMAL

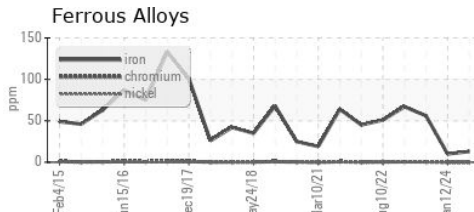
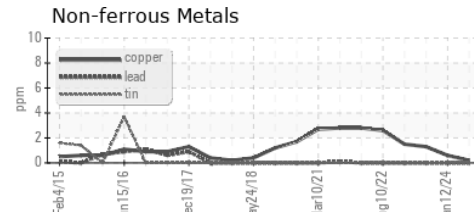
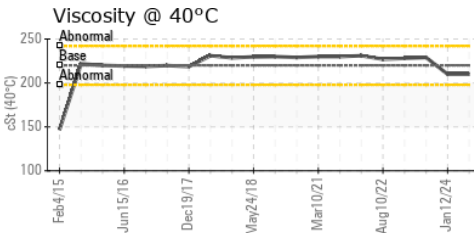
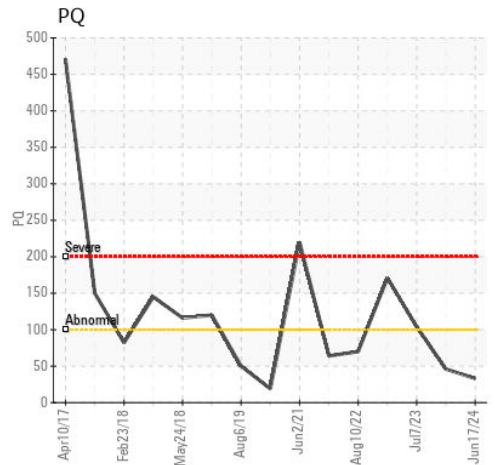
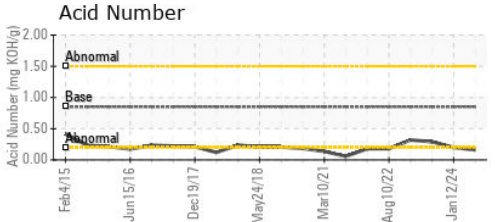
GRAPHS

All component wear rates are normal.

There is no indication of any contamination in the oil.

The AN level is acceptable for this fluid. The condition of the oil is suitable for further service.

Resample at the next service interval to monitor.
