OIL ANALYSIS REPORT

SLITTER HEAD (S/N 16-5300-0225)

Gearbox

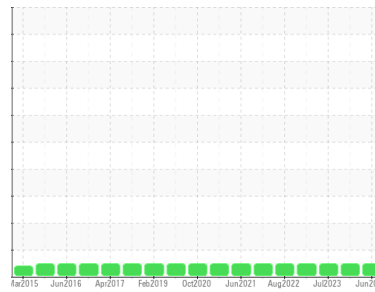
Sample Rating Trend

NORMAL

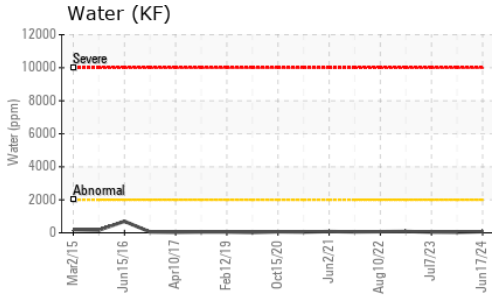
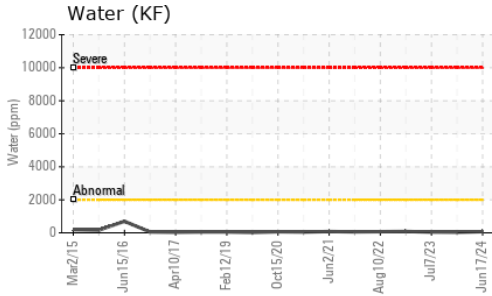
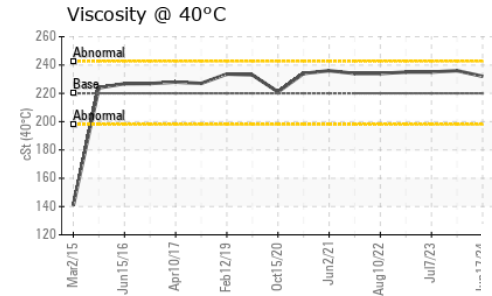
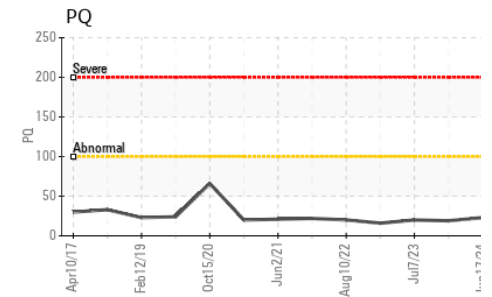
All component wear rates are normal.

There is no indication of any contamination in the oil.

The AN level is acceptable for this fluid. The condition of the oil is suitable for further service.

Resample at the next service interval to monitor.
