OIL ANALYSIS REPORT

EL SAUZ [200007686]

M04WEA90360 (S/N W-123194)

Wind Turbine Gearbox

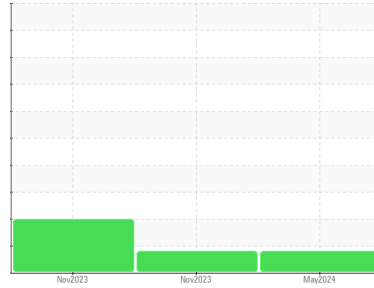
Sample Rating Trend

There is a high amount of silt (particulates < 14 microns in size) present in the oil.

No corrective action is recommended at this time. Resample at the next service interval to monitor.

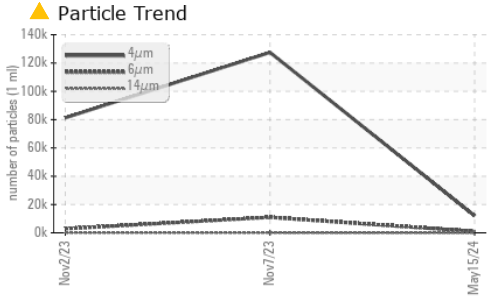
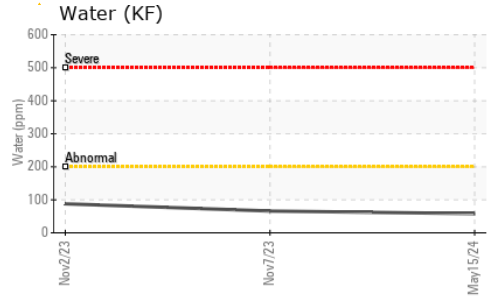
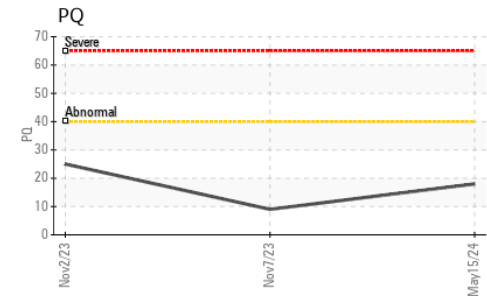
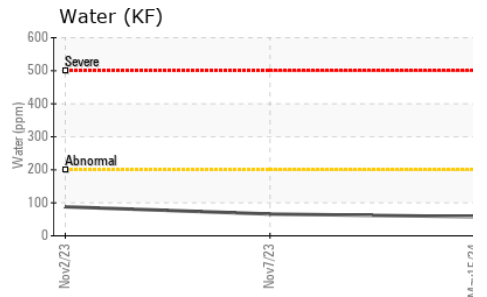
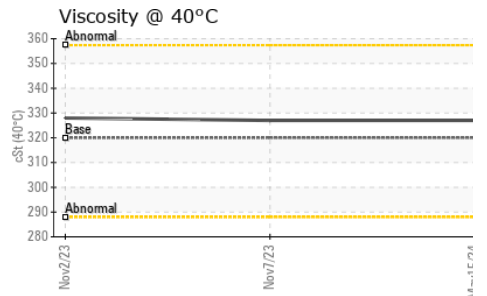
All component wear rates are normal.

The AN level is acceptable for this fluid. The condition of the oil is suitable for further service.

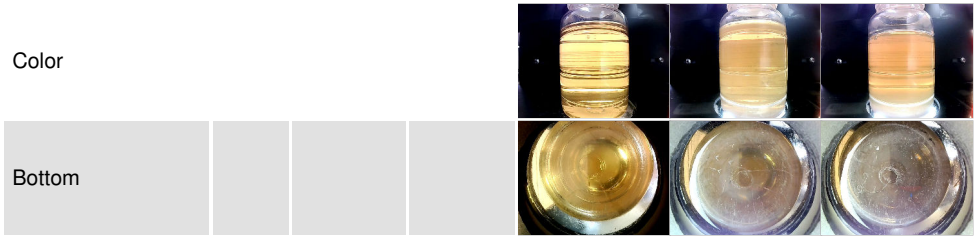
SAMPLE IMAGES	method	limit/base	current	history1	history2
---------------	--------	------------	---------	----------	----------

VISUAL	method	limit/base	current	history1	history2
White Metal	scalar	*Visual	NONE	NONE	NONE
Yellow Metal	scalar	*Visual	NONE	NONE	NONE
Precipitate	scalar	*Visual	NONE	NONE	NONE
Silt	scalar	*Visual	NONE	NONE	NONE
Debris	scalar	*Visual	NONE	NONE	NONE
Sand/Dirt	scalar	*Visual	NONE	NONE	NONE
Appearance	scalar	*Visual	NORML	NORML	NORML
Odor	scalar	*Visual	NORML	NORML	NORML
Emulsified Water	scalar	*Visual	>0.02	NEG	NEG
Free Water	scalar	*Visual		NEG	NEG

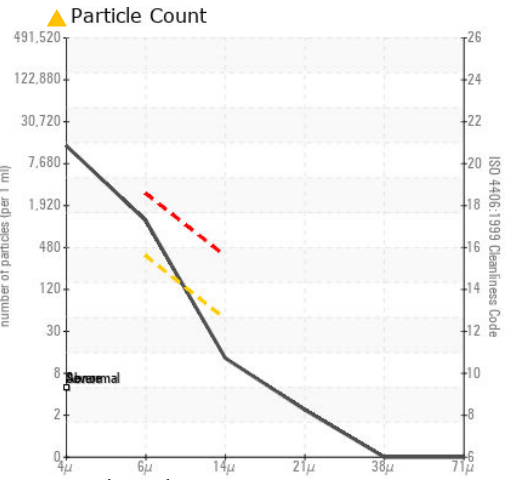
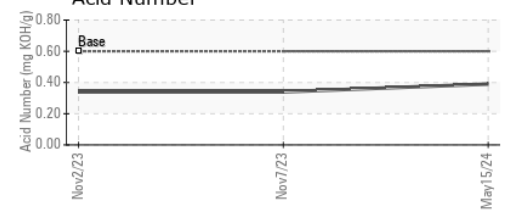
GRAPHS

method	limit/base	current	history1	history2
Particles >4µm	ASTM D7647		12053	127492	81278
Particles >6µm	ASTM D7647	>320	▲ 1021	▲ 10954	▲ 2858
Particles >14µm	ASTM D7647	>40	11	28	▲ 71
Particles >21µm	ASTM D7647	>10	2	2	▲ 23
Particles >38µm	ASTM D7647	>3	0	1	▲ 3
Particles >71µm	ASTM D7647	>3	0	0	1
Oil Cleanliness	ISO 4406 (c)	>--/15/12	▲ 21/17/11	▲ 24/21/12	▲ 24/19/13
