OIL ANALYSIS REPORT

Area CO GEN Machine Id BRUSH GENERATOR

Turbine Fluid SHELL TURBO T ISO 32 (--- GAL)

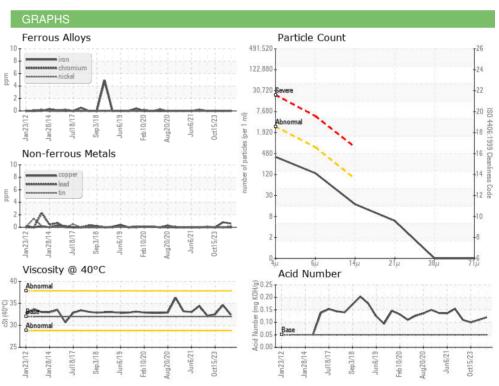
Bottom

)//OLIAL						
VISUAL		method	limit/base	current	history1	history2
White Metal	scalar	*Visual	NONE	NONE	NONE	NONE
Yellow Metal	scalar	*Visual	NONE	NONE	NONE	NONE
Precipitate	scalar	*Visual	NONE	NONE	NONE	NONE
Silt	scalar	*Visual	NONE	NONE	NONE	NONE
Debris	scalar	*Visual	NONE	NONE	NONE	NONE
Sand/Dirt	scalar	*Visual	NONE	NONE	NONE	NONE
Appearance	scalar	*Visual	NORML	NORML	NORML	NORML
Odor	scalar	*Visual	NORML	NORML	NORML	NORML
Emulsified Water	scalar	*Visual	>0.03	NEG	NEG	NEG
Free Water	scalar	*Visual		NEG	NEG	NEG
FLUID PROPERTIES		method	limit/base	current	history1	history2
Visc @ 40°C	cSt	ASTM D445	32	32.4	34.6	32.5
SAMPLE IMAGES		method	limit/base	current	history1	history2
Color
