OIL ANALYSIS REPORT

Area
Building 12
 Machine Id
Roll Crusher 3
 Component
Southwest Bearing
 Fluid
MOBIL MOBILGEAR 600 XP ISO 68 (3 GAL)

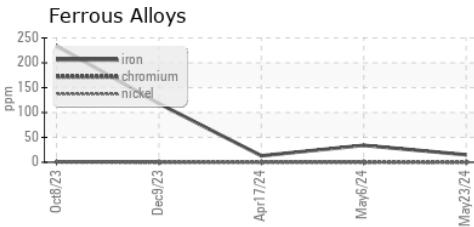
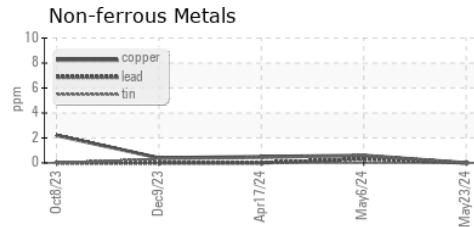
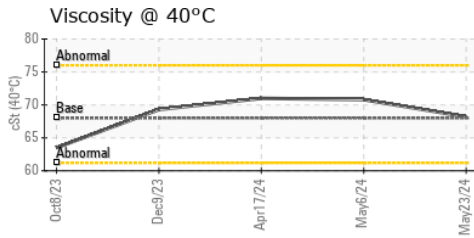
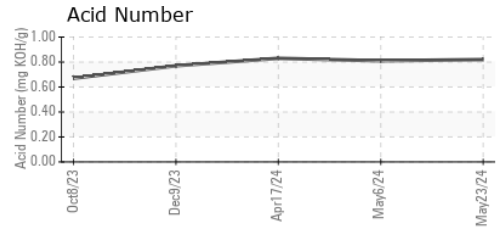
GRAPHS

method	limit/base	current	history1	history2
Iron	ppm	ASTM D5185m >20	15	34	13
Chromium	ppm	ASTM D5185m >20	0	<1	<1
Nickel	ppm	ASTM D5185m >20	0	<1	<1
Titanium	ppm	ASTM D5185m	0	<1	<1
Silver	ppm	ASTM D5185m	0	0	<1
Aluminum	ppm	ASTM D5185m >20	<1	2	2
Lead	ppm	ASTM D5185m >20	0	<1	0
Copper	ppm	ASTM D5185m >20	0	<1	<1
Tin	ppm	ASTM D5185m >20	0	<1	<1
Vanadium	ppm	ASTM D5185m	0	0	<1
Cadmium	ppm	ASTM D5185m	0	<1	<1
