OIL ANALYSIS REPORT

Area
KANSAS/44
 Machine Id
38.87 [KANSAS^44]
 Component
Rear Right Final Drive
 Fluid
MOBIL MOBILTRANS HD 50 (--- GAL)

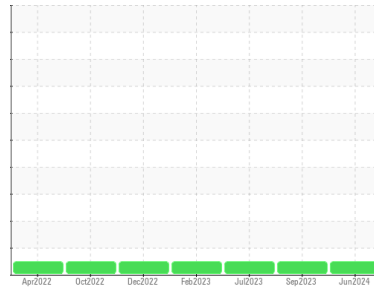
Sample Rating Trend

NORMAL

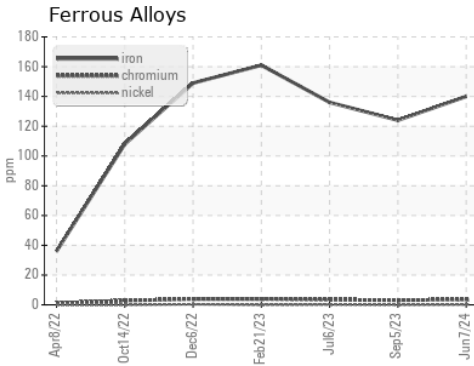
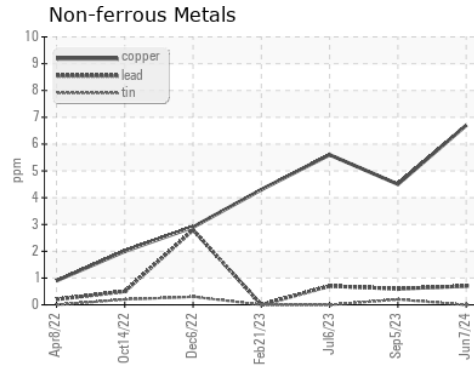
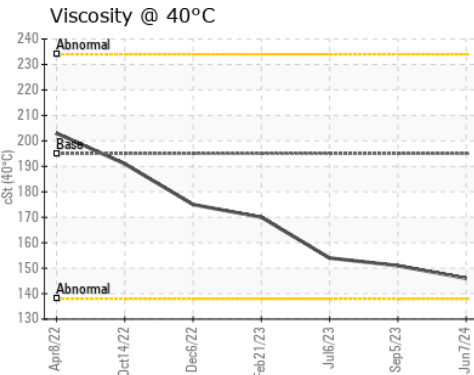
GRAPHS

All component wear rates are normal.

There is no indication of any contamination in the oil.

The condition of the oil is acceptable for the time in service.

Resample at the next service interval to monitor.
