OIL ANALYSIS REPORT

Area
COLORADO/443/EG - LOADER
 Machine Id
47.11L [COLORADO^443^EG - LOADER]
 Component
Transmission (Manual)
 Fluid
MOBIL MOBILTRANS AST 30 (--- GAL)

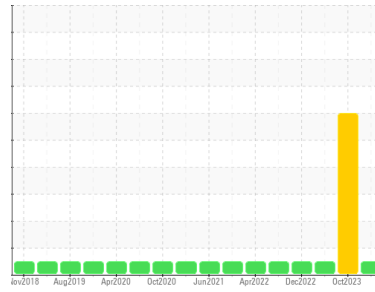
Sample Rating Trend

NORMAL

Resample at the next service interval to monitor.

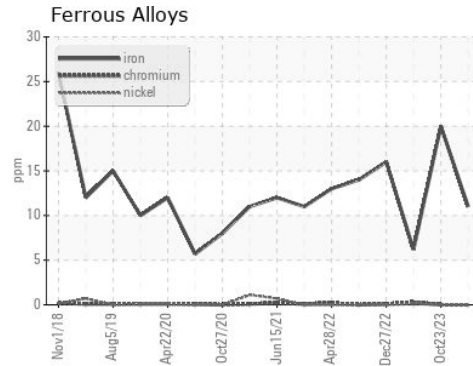
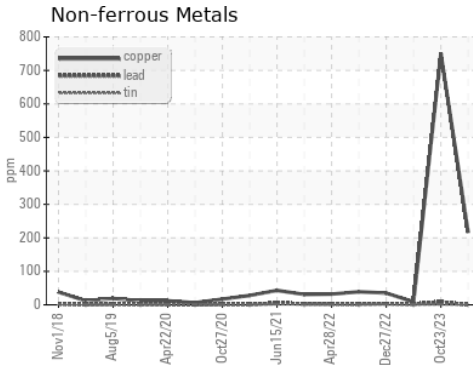
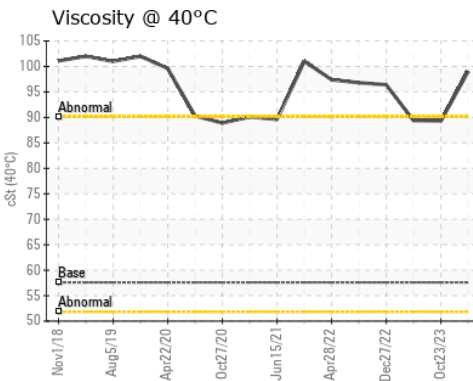
GRAPHS

All component wear rates are normal.

There is no indication of any contamination in the fluid.

The condition of the fluid is acceptable for the time in service.
