OIL ANALYSIS REPORT

Machine Id
DEISTER 14037 DRAIN PLUG SHAFT (S/N 1070609)
 Component
Gearbox
 Fluid
MOBIL SHC 632 (--- GAL)

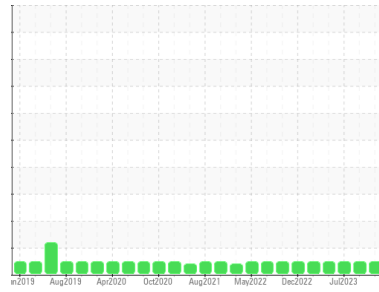
Sample Rating Trend

NORMAL

Resample at the next service interval to monitor.

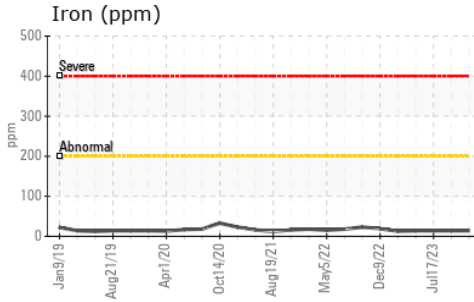
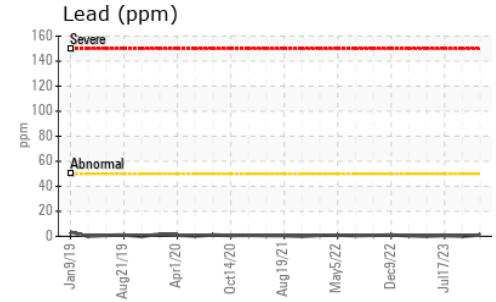
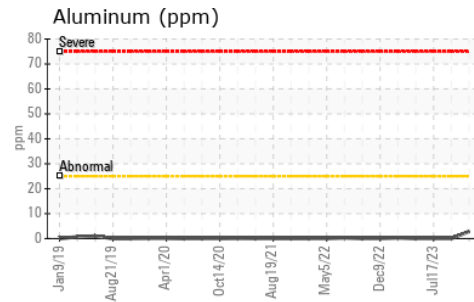
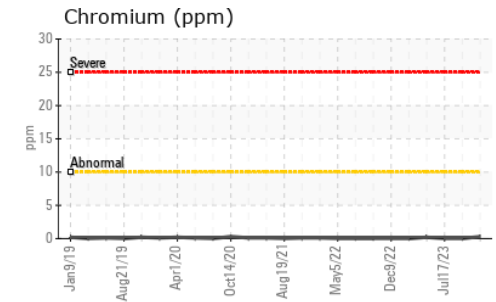
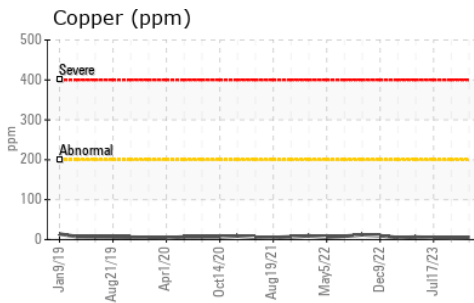
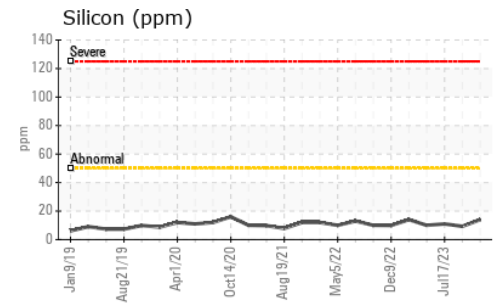
GRAPHS

All component wear rates are normal.

There is no indication of any contamination in the oil.

The condition of the oil is acceptable for the time in service.
