SULLIVAN PALATEK 1510230006 - WASTE MGMT MAHONING LANDFILL

Compressor

OIL ANALYSIS REPORT

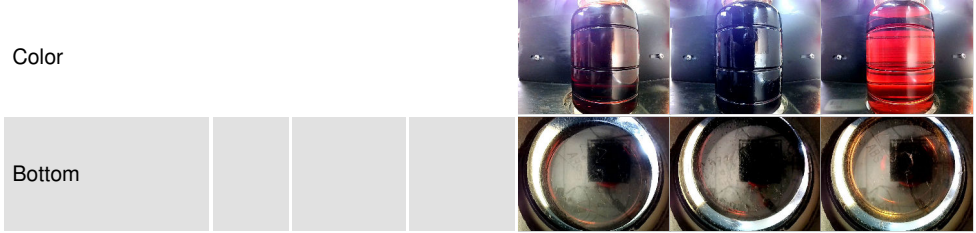
SAMPLE IMAGES	method	limit/base	current	history1	history2
---------------	--------	------------	---------	----------	----------

VISUAL	method	limit/base	current	history1	history2
White Metal	scalar	*Visual	NONE	NONE	NONE
Yellow Metal	scalar	*Visual	NONE	NONE	NONE
Precipitate	scalar	*Visual	NONE	NONE	NONE
Silt	scalar	*Visual	NONE	NONE	NONE
Debris	scalar	*Visual	NONE	NONE	NONE
Sand/Dirt	scalar	*Visual	NONE	NONE	NONE
Appearance	scalar	*Visual	NORML	NORML	NORML
Odor	scalar	*Visual	NORML	NORML	NORML
Emulsified Water	scalar	*Visual	>0.1	NEG	NEG
Free Water	scalar	*Visual		NEG	NEG

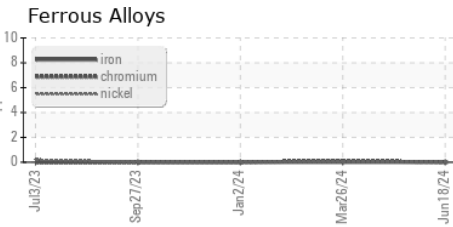
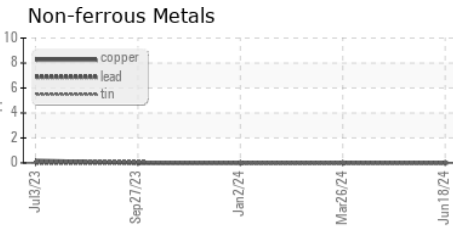
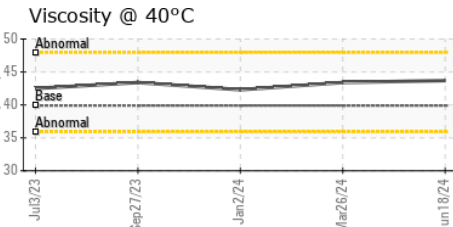
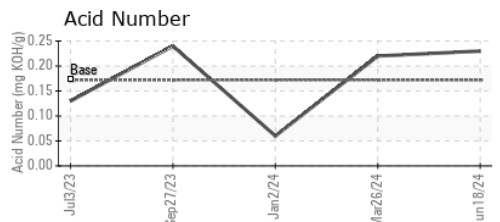
GRAPHS

All component wear rates are normal.

The AN level is acceptable for this fluid. The condition of the oil is suitable for further service.

Resample at the next service interval to monitor.
