OIL ANALYSIS REPORT

CRM 74 FEED LEVELER - REDUCER (S/N 16-2400-0130)

Gearbox

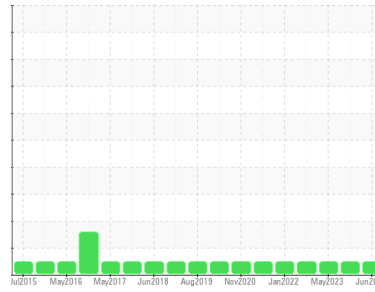
Sample Rating Trend

NORMAL

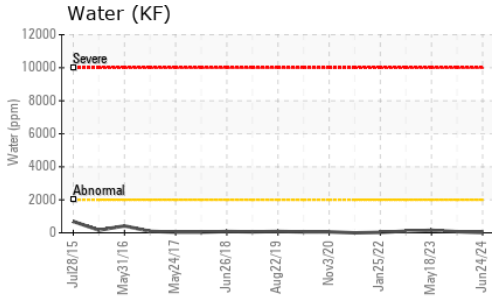
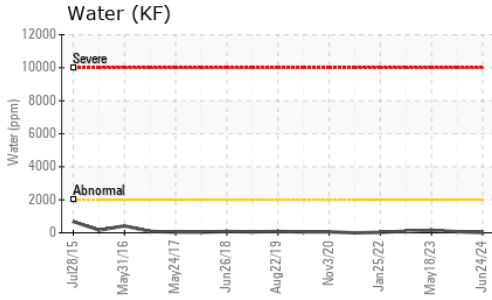
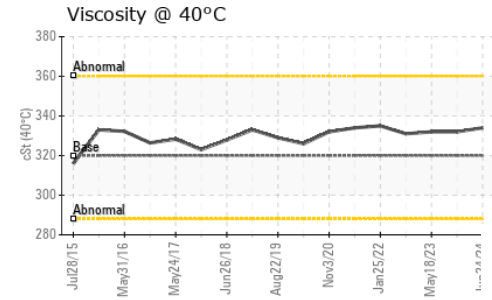
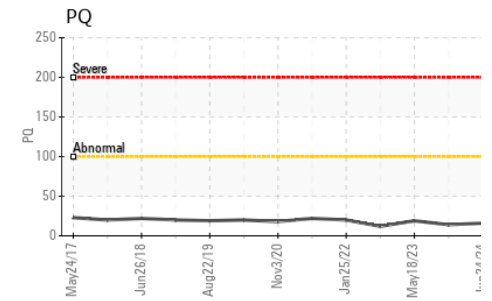
VISUAL	method	limit/base	current	history1	history2
White Metal	scalar	*Visual	NONE	NONE	NONE
Yellow Metal	scalar	*Visual	NONE	NONE	NONE
Precipitate	scalar	*Visual	NONE	NONE	NONE
Silt	scalar	*Visual	NONE	NONE	NONE
Debris	scalar	*Visual	NONE	NONE	NONE
Sand/Dirt	scalar	*Visual	NONE	NONE	NONE
Appearance	scalar	*Visual	NORML	NORML	NORML
Odor	scalar	*Visual	NORML	NORML	NORML
Emulsified Water	scalar	*Visual	>0.2	NEG	NEG
Free Water	scalar	*Visual		NEG	NEG

FLUID PROPERTIES	method	limit/base	current	history1	history2
Visc @ 40°C	cSt	ASTM D445	320	334	332

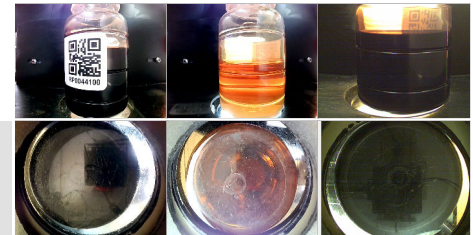
SAMPLE IMAGES	method	limit/base	current	history1	history2
---------------	--------	------------	---------	----------	----------

Color

Bottom
