# PROBLEM SUMMARY

**GA615 - UPI**

**Hydraulic System**

# OIL ANALYSIS REPORT

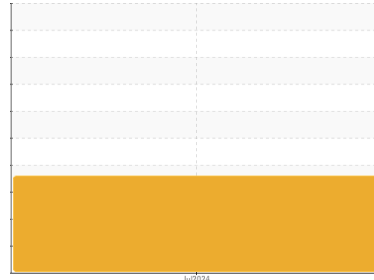
## Sample Rating Trend

Sample Status			<b>SEVERE</b>	---	---
Particles >4µm	ASTM D7647	>5000	<b>▲ 86786</b>	---	---
Particles >6µm	ASTM D7647	>1300	<b>▲ 11777</b>	---	---
Oil Cleanliness	ISO 4406 (c)	>19/17/14	<b>▲ 24/21/14</b>	---	---

Check seals and/or filters for points of contaminant entry. The air breather requires service. If unrated, we recommend that you replace with a suitable micron rated and/or desiccant air breather. If rated, we recommend that you service/replace the breather. We recommend you service the filters on this component. Resample in 30-45 days to monitor this situation. Please specify the component make and model with your next sample. Please specify the brand, type, and viscosity of the oil on your next sample.

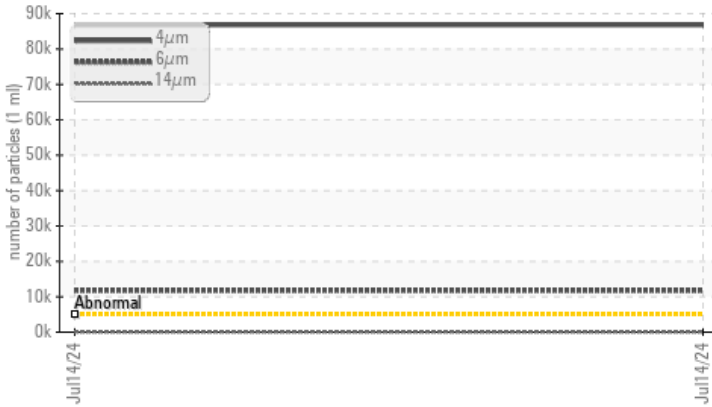
### ▲ Particle Trend

There is a high amount of silt (particulates < 14 microns in size) present in the oil.
