# OIL ANALYSIS REPORT

**Laboratory** : WearCheck USA - 501 Madison Ave., Cary, NC 27513  
**Sample No.** : Y2K0001817      **Received** : 17 Jul 2024  
**Lab Number** : 06239192      **Tested** : 19 Jul 2024  
**Unique Number** : 11128026      **Diagnosed** : 19 Jul 2024 - Jonathan Hester  
**Test Package** : MOB 2 ( Additional Tests: KF, PrtCount )

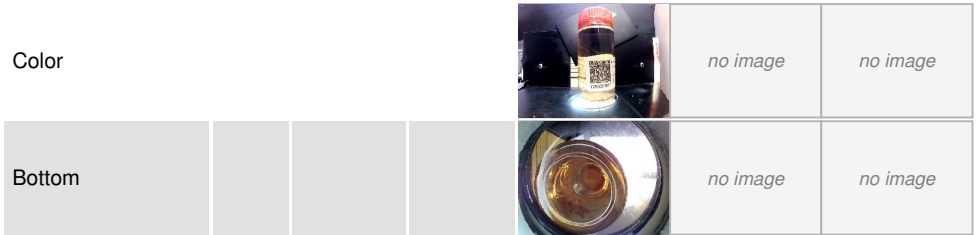
SAMPLE IMAGES	method	limit/base	current	history1	history2
---------------	--------	------------	---------	----------	----------

VISUAL	method	limit/base	current	history1	history2
White Metal	scalar	*Visual	NONE	NONE	---
Yellow Metal	scalar	*Visual	NONE	NONE	---
Precipitate	scalar	*Visual	NONE	NONE	---
Silt	scalar	*Visual	NONE	NONE	---
Debris	scalar	*Visual	NONE	NONE	---
Sand/Dirt	scalar	*Visual	NONE	NONE	---
Appearance	scalar	*Visual	NORML	NORML	---
Odor	scalar	*Visual	NORML	NORML	---
Emulsified Water	scalar	*Visual	>0.01	NEG	---
Free Water	scalar	*Visual		NEG	---
