PROBLEM SUMMARY

Area
PG-46 [293300]
 Machine Id
PNEUTECH AK100008523 - STONE CRAFTERS
 Component
Compressor

OIL ANALYSIS REPORT

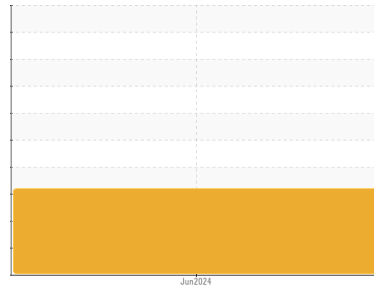
Sample Rating Trend

DEGRADATION

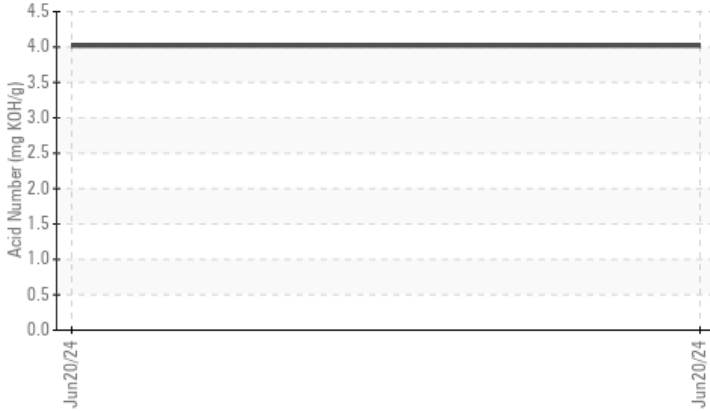
COMPONENT CONDITION SUMMARY

▲ Acid Number

| Sample Status | mg KOH/g | ASTM D8045 | SEVERE | --- | --- |
| Acid Number (AN) | 4.02 | | ▲ 4.02 | --- | --- |

The AN level is above the recommended limit. The oil is no longer serviceable.

We advise that you check for a possible overheat condition. Oil and filter change at the time of sampling has been noted. We recommend an early resample to monitor this condition.

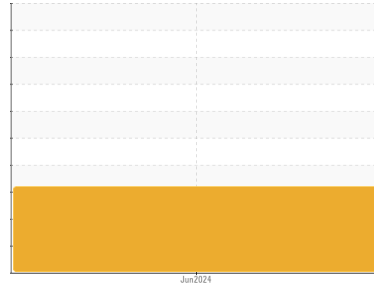
Sample Rating Trend

DEGRADATION

▲ Fluid Condition

We advise that you check for a possible overheat condition. Oil and filter change at the time of sampling has been noted. We recommend an early resample to monitor this condition.
