Laboratoire : WearCheck - C8-1175 Appleby Line, Burlington, ON L7L 5H9
N° d'échantillon : WC
N° de laboratoire : 02639279
Numéro unique : 5788441
Analyse : TEST (Additional Tests: ICP-NewOil)

Envirolin Canada

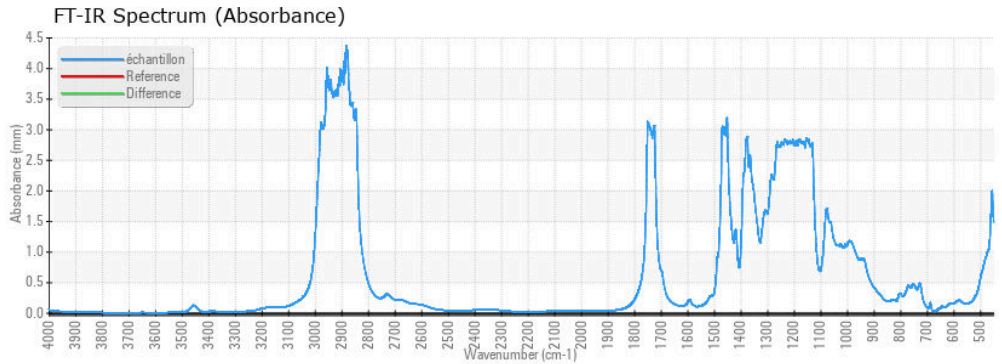
GRAPHIQUES

| PROPRIÉTÉS DU FLUID | methode | limite/base | actuel | passé1 | passé2 |
|---|---|---|---|---|---|
| Visc 40°C | cSt | ASTM D7279(m) | 47.0 | 44.8 | --- |
| Visc 100°C | cSt | ASTM D7279(m) | 8.1 | 8.3 | --- |
| Indice de viscosité (VI) | Scale | ASTM D2270* | 146 | 162 | --- |
