FT-IR (Direct Trend)

Laboratoire : WearCheck - C8-1175 Appleby Line, Burlington, ON L7L 5H9

Analyse : TEST (Additional Tests: ICP-NewOil)

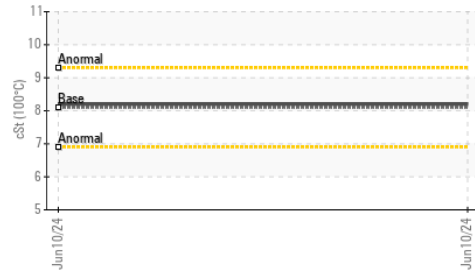
Viscosité 100°C

PROPRIÉTÉS DU FLUID	methode	limite/base	actuel	passé1	passé2
Visc 40°C	cSt	ASTM D7279(m)	47.0	44.6	---
Visc 100°C	cSt	ASTM D7279(m)	8.1	8.2	---
Indice de viscosité (VI)	Scale	ASTM D2270*	146	160	---
