# OIL ANALYSIS REPORT

## 80085673 - DIESEL ENGINE

Sample No: VPA052234

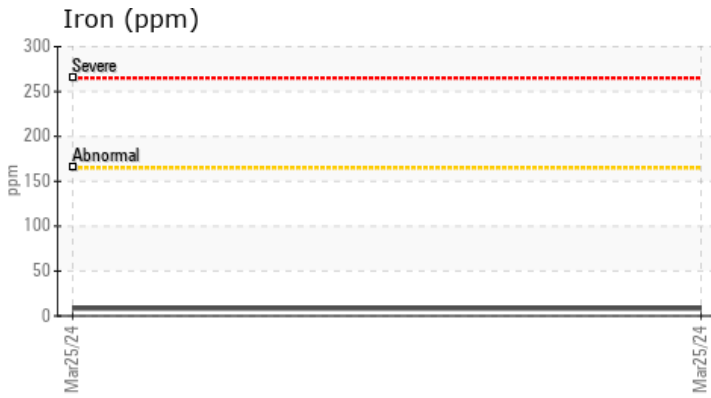
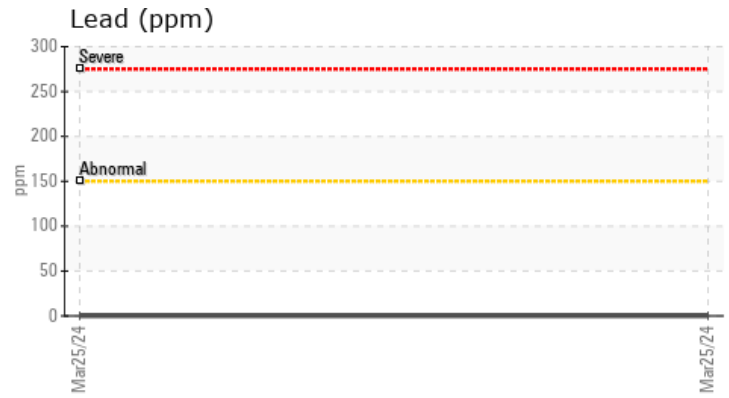
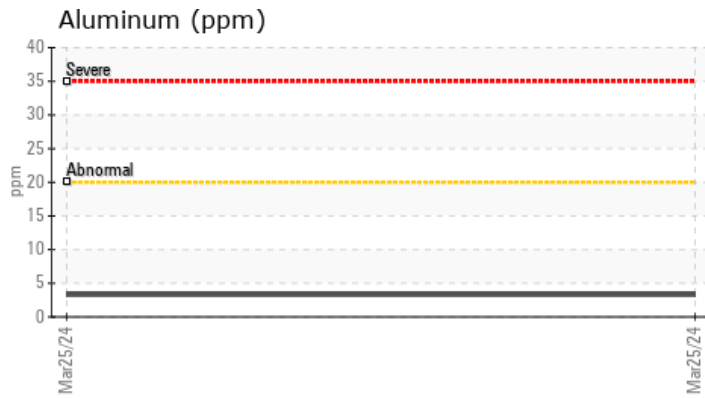
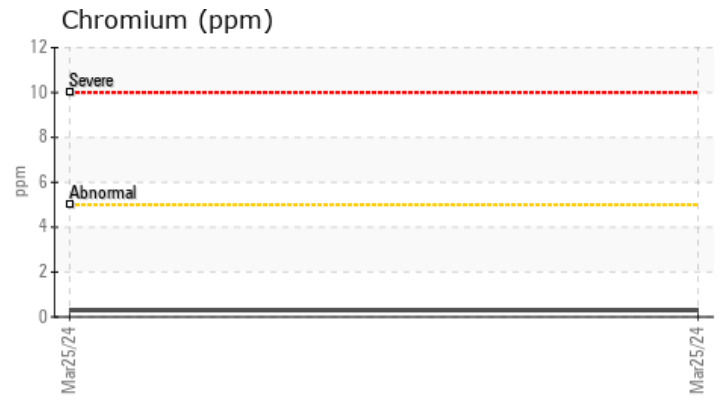
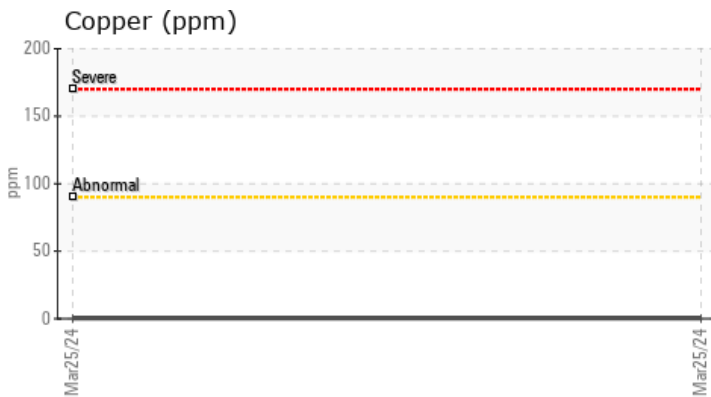
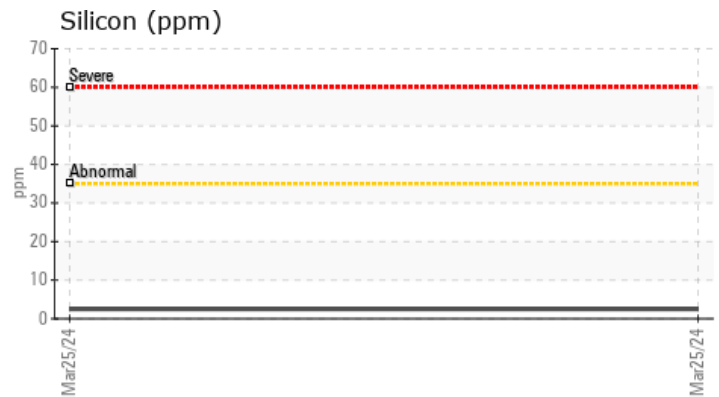
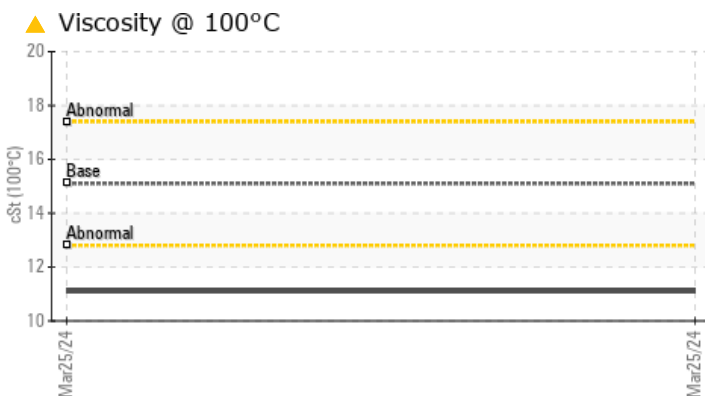
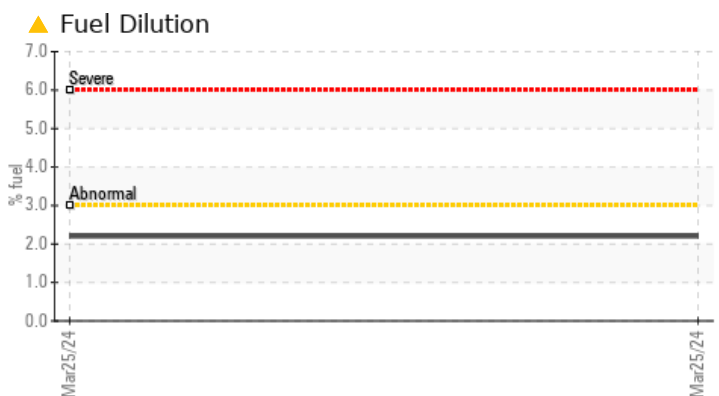
## GRAPHS

The oil change at the time of sampling has been noted. Resample at the next service interval to monitor. All component wear rates are normal. Elevated aluminum (Al) and/or lead (Pb) and potassium (K) levels in your metals analysis are likely a result of solder flux release into the lubricant and is common on new equipment/components. Light fuel dilution occurring. Fuel is present in the oil and is lowering the viscosity. The condition of the oil is acceptable for the time in service.
