CONSTRUCTION EQUIPMENT

X28006 VOLVO A25G 752153 - DIESEL ENGINE

Sample No: VCBM007630
Oil Type: VOLVO ULTRA DIESEL ENGINE OIL 15W40 VDS-3
Job No: X28006

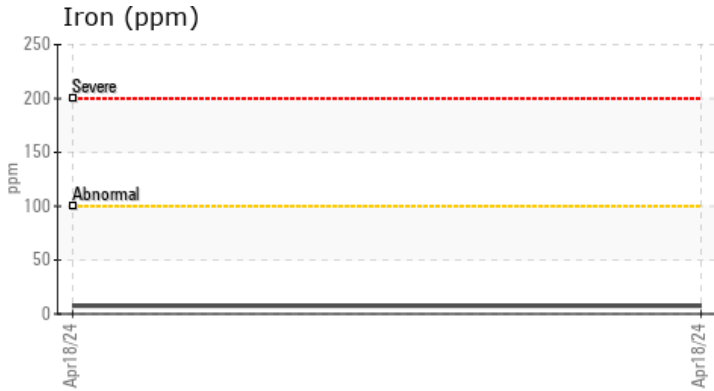
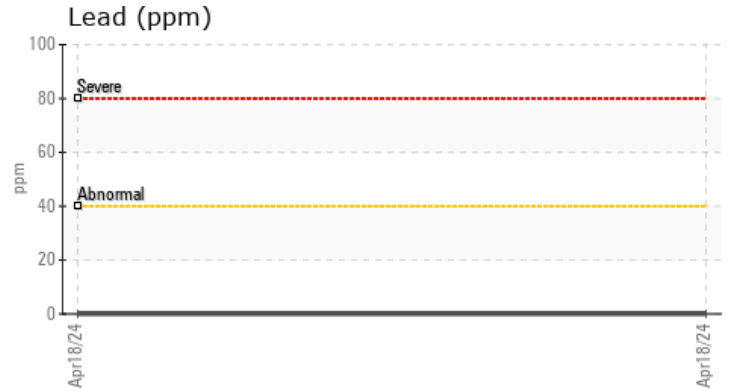
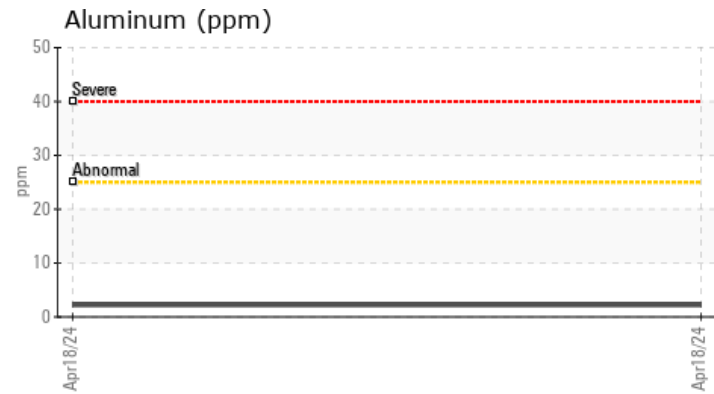
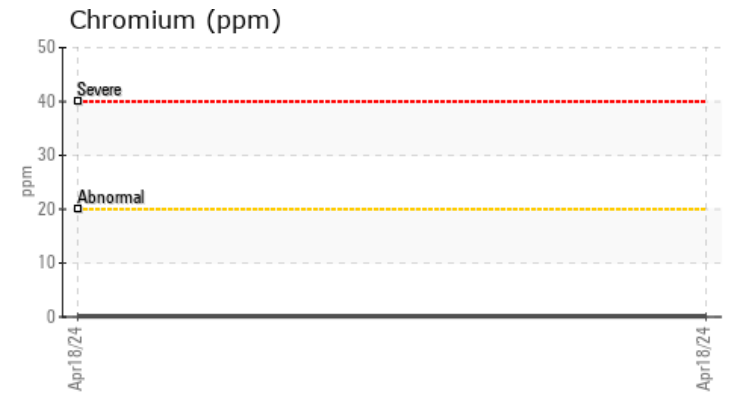
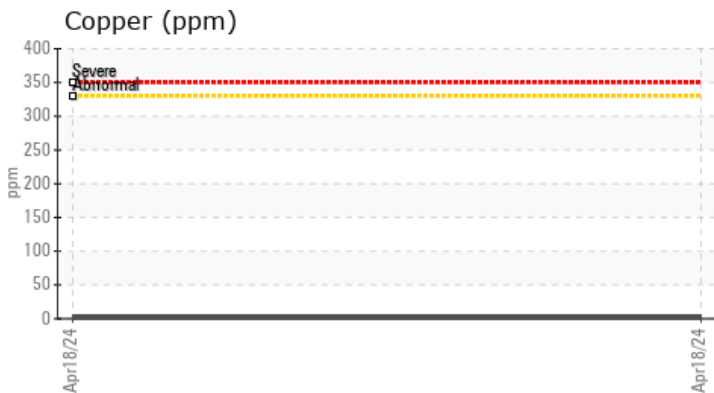
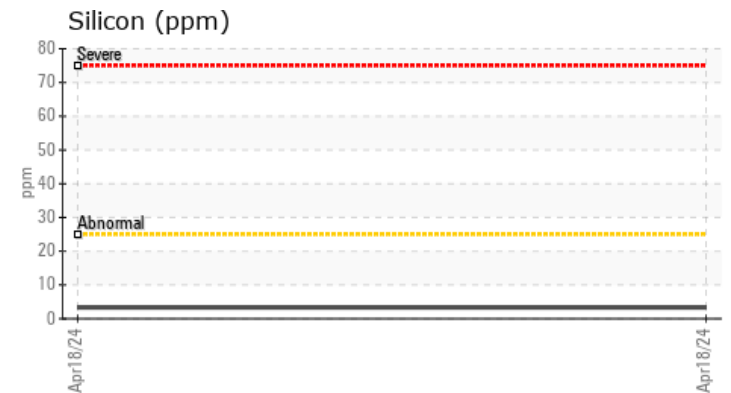
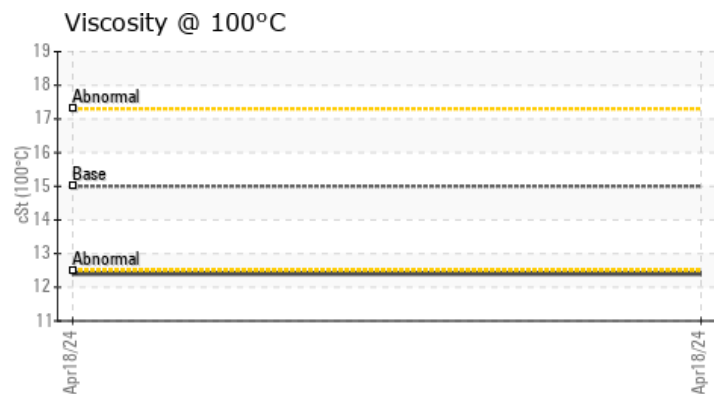
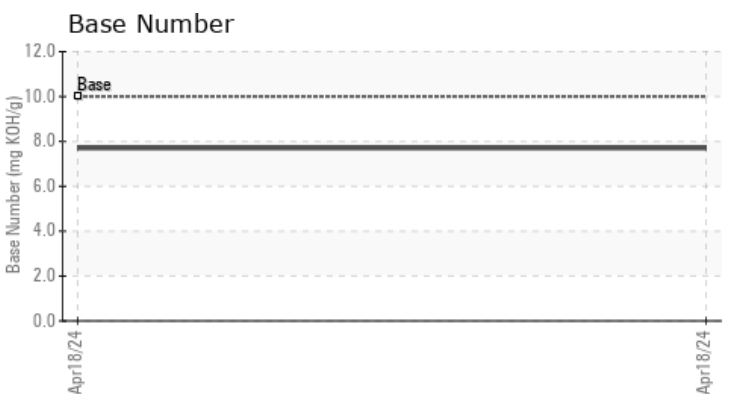
GRAPHS

Oil and filter change at the time of sampling has been noted. No corrective action is recommended at this time. Resample at the next service interval to monitor. All component wear rates are normal. Fuel content negligible. No other contaminants were detected in the oil. The BN result indicates that there is suitable alkalinity remaining in the oil. The condition of the oil is acceptable for the time in service.
