4675951 (S/N 1441)

Compressor

KAESER SIGMA (OEM) S-460 (--- GAL)

OIL ANALYSIS REPORT

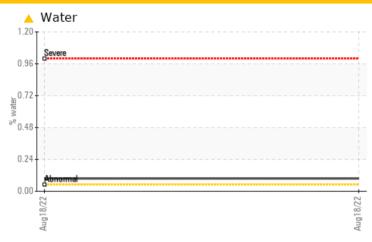
COMPONENT CONDITION SUMMARY

PROBLEMATIC TEST RESULTS								
Sample Status				ABNORMAL				
Water	%	ASTM D6304	>0.05	△ 0.096				
ppm Water	ppm	ASTM D6304	>500	4 960				
Silt	scalar	*Visual	NONE	MODER

There is a light concentration of water present in the oil. There is a moderate amount of visible silt present in the sample.

The filter change at the time of sampling has been noted. We were unable to perform a particle count due to a high concentration of particles present in this sample. We advise that you stop the unit and follow the water drain-off procedure for this component. We recommend an early resample in 500 hours to monitor this condition.

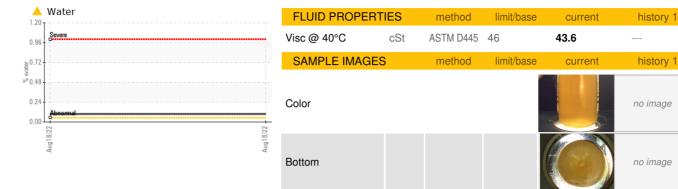
GRAPHS

Silicon	ppm	ASTM D5185m	>25	0		
Sodium	ppm	ASTM D5185m		2		
Potassium	ppm	ASTM D5185m	>20	0		
Water	%	ASTM D6304	>0.05	0.096		
ppm Water	ppm	ASTM D6304	>500	<u></u> 4960		
FLUID DEGRADA	ATION	method	limit/base	current	history 1	history 2
Acid Number (AN)	mg KOH/g	ASTM D8045	0.4	0.22		
VISUAL		method	limit/base	current	history 1	history 2
White Metal	scalar	*Visual	NONE	NONE		
Yellow Metal	scalar	*Visual	NONE	NONE		
Precipitate	scalar	*Visual	NONE	NONE		
Silt	scalar	*Visual	NONE	▲ MODER		
Debris	scalar	*Visual	NONE	NONE		
Sand/Dirt	scalar	*Visual	NONE	NONE		
Appearance	scalar	*Visual	NORML	NORML		
Odor	scalar	*Visual	NORML	NORML		
Emulsified Water	scalar	*Visual	>0.05	0.2%		
Free Water	scalar	*Visual		NEG	on: Service Mar	agerSTAMTA
