# PROBLEM SUMMARY

Machine Id  
**2877267 (S/N 1054)**

Component  
**Compressor**  
Fluid  
**NOT GIVEN (--- GAL)**

# OIL ANALYSIS REPORT

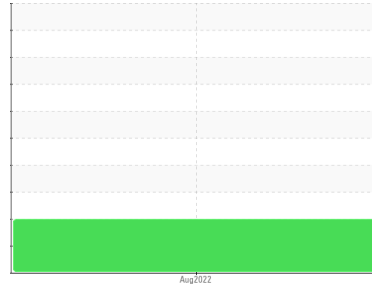
Sample Rating Trend

All component wear rates are normal.

The AN level is acceptable for this fluid. The condition of the oil is acceptable for the time in service.

We recommend you service the filters on this component. Resample at the next service interval to monitor.
