Machine Id
KAESER 7909270

Component
Compressor

Fluid
KAESER SIGMA (OEM) M-460 (--- GAL)

OIL ANALYSIS REPORT

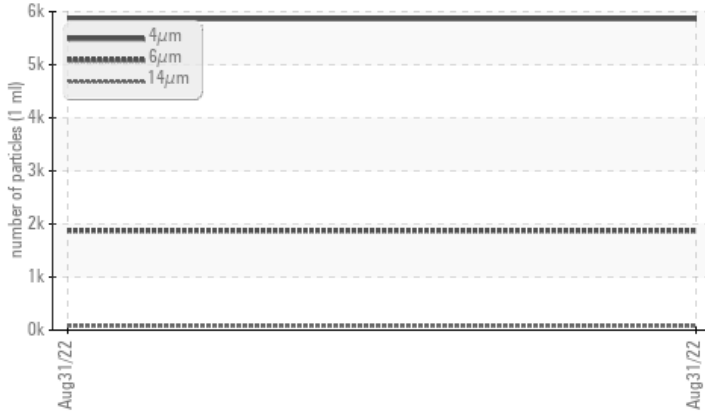
▲ Particle Trend

Sample Status			ATTENTION	---	---
Particles >6µm	ASTM D7647	>1300	▲ 1873	---	---
Oil Cleanliness	ISO 4406 (c)	>--/17/13	▲ 20/18/13	---	---

There is a moderate amount of silt (particulates < 14 microns in size) present in the oil.

Oil and filter change at the time of sampling has been noted. Resample at the next service interval to monitor.
