Machine Id **7441137 (S/N 1140)**

Component Compressor

KAESER SIGMA (OEM) M-460 (--- GAL)

OIL ANALYSIS REPORT

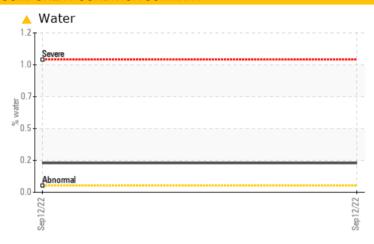
COMPONENT CONDITION SUMMARY

All component wear rates are normal.

Appearance is hazy. There is a light concentration of water present in the oil. Moderate concentration of visible dirt/debris present in the oil.

The AN level is acceptable for this fluid. The condition of the oil is suitable for further service.

Oil and filter change at the time of sampling has been noted. We were unable to perform a particle count due to a high concentration of particles present in this sample. We recommend an early resample in 500 hours to monitor this condition.
