# PROBLEM SUMMARY

Machine Id  
**KAESER 7726709**

Component  
**Compressor**

# OIL ANALYSIS REPORT

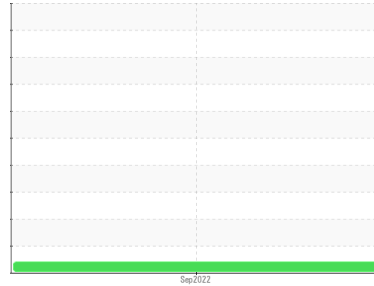
Sample Rating Trend

**VIS DEBRIS**

Sample Status				<b>ABNORMAL</b>	---	---
Debris	scalar	*Visual	NONE	<b>▲ MODER</b>	---	---

Oil and filter change at the time of sampling has been noted. Resample at the next service interval to monitor. We were unable to perform a particle count due to a high concentration of particles present in this sample.

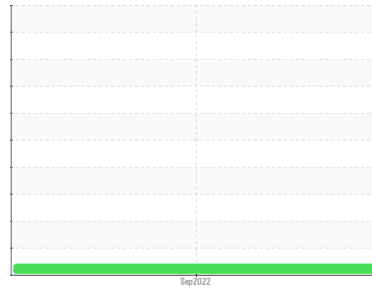
Sample Rating Trend

**VIS DEBRIS**

Moderate concentration of visible dirt/debris present in the oil.

Oil and filter change at the time of sampling has been noted. Resample at the next service interval to monitor. We were unable to perform a particle count due to a high concentration of particles present in this sample.

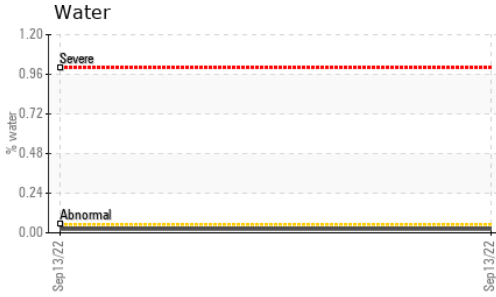
SAMPLE IMAGES	method	limit/base	current	history 1	history 2
---------------	--------	------------	---------	-----------	-----------

VISUAL	method	limit/base	current	history 1	history 2
White Metal	scalar	*Visual	NONE	<b>NONE</b>	---
Yellow Metal	scalar	*Visual	NONE	<b>NONE</b>	---
Precipitate	scalar	*Visual	NONE	<b>NONE</b>	---
Silt	scalar	*Visual	NONE	<b>NONE</b>	---
Debris	scalar	*Visual	NONE	<b>MODER</b>	---
Sand/Dirt	scalar	*Visual	NONE	<b>NONE</b>	---
Appearance	scalar	*Visual	NORML	<b>NORML</b>	---
Odor	scalar	*Visual	NORML	<b>NORML</b>	---
Emulsified Water	scalar	*Visual	>0.05	<b>NEG</b>	---
Free Water	scalar	*Visual		<b>NEG</b>	---

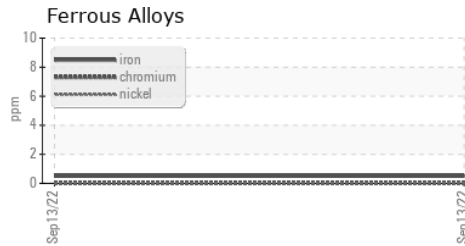
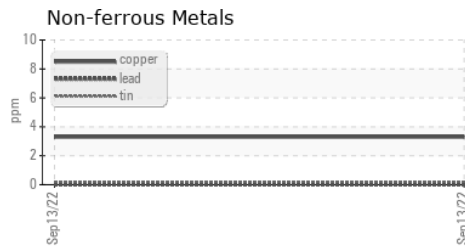
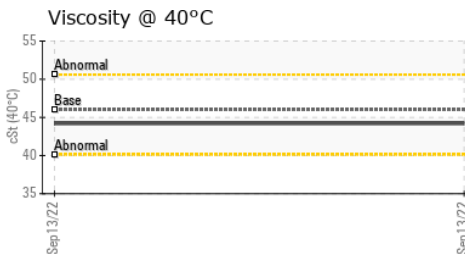
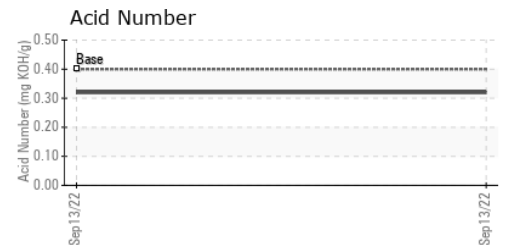
## GRAPHS

All component wear rates are normal.

The AN level is acceptable for this fluid. The condition of the oil is suitable for further service.
