# PROBLEM SUMMARY

# OIL ANALYSIS REPORT

Machine Id  
**KAESER BSV 100 6341326 (S/N 1081)**  
Component  
**Compressor**  
Fluid  
**KAESER SIGMA (OEM) S-460 (--- GAL)**

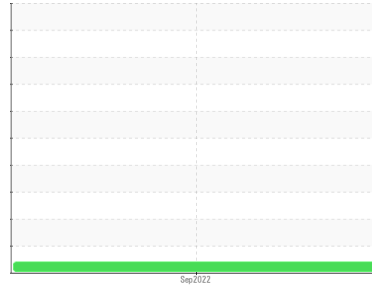
Sample Rating Trend

**VIS DEBRIS**

Moderate concentration of visible dirt/debris present in the oil.

The filter change at the time of sampling has been noted. Resample at the next service interval to monitor. We were unable to perform a particle count due to a high concentration of particles present in this sample.
